**Tree Inventory, Assessment,
and
Protection**

**400 Surmont Drive
Los Gatos, CA 95032**

Town of Los Gatos

September 27, 2019

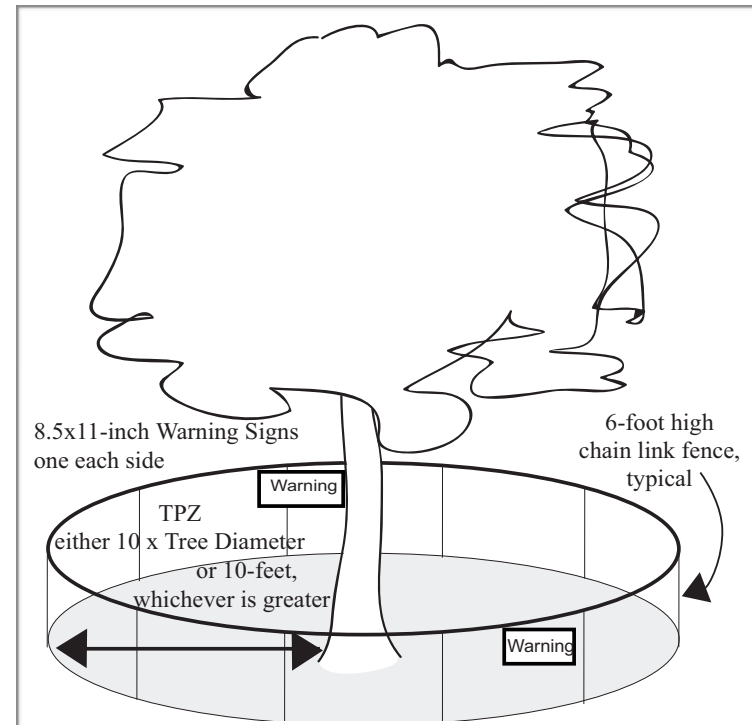
Figure 1: Type I Tree protection with fence placed at a radius of ten times the trunk diameter. Image City of Palo Alto 2006.

Tree protection for this project would consist of a Type I scheme around all the trees to be retained with a maximum encroachment radius of six times the trunk diameter distance or at the drip line distance. If any tree is to be impacted on multiple sides the tree protection radius would need to be expanded to twelve times the trunk diameter radius in feet.

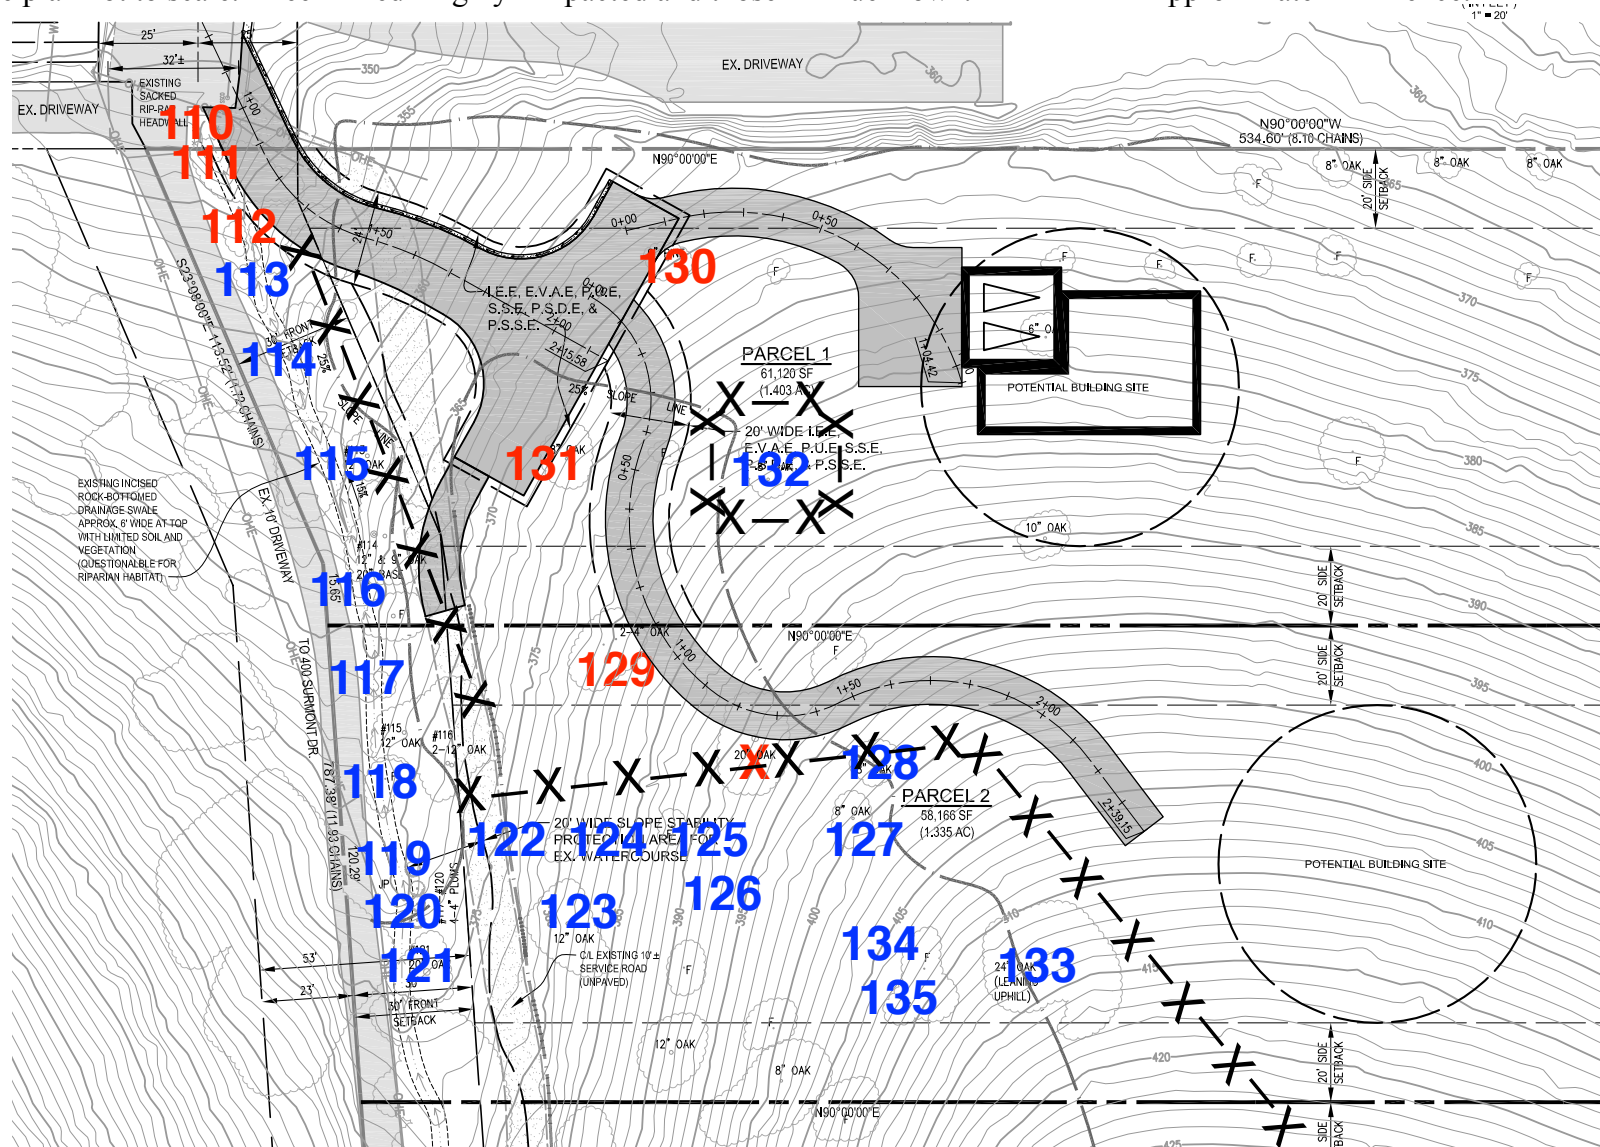
Appendix A: Site Plan

The plans provided indicated the proposed location of the driveway to the two lots. The topographic survey provided is not completely accurate and the red "X" located on the plan in Appendix A indicates at least one oak that has been removed.

There are six trees within the footprint of the proposed driveway and two in or near the proposed building sites (Chart 4). From what was provided there will be at least six trees lost due to the driveway configuration (Appendix A).

Site plan not to scale. Tree in Red “highly” impacted and those in Blue “low”. X—X—X = Approximate TPZ Fence.

3. Place tree protection fence along the service road near the drainage outside the tree dip lines, around #132, and adjacent to #122, #124, #125, #128 and #133.
